An Taisce
The National Trust for Ireland

Buildings at Risk

November 2014

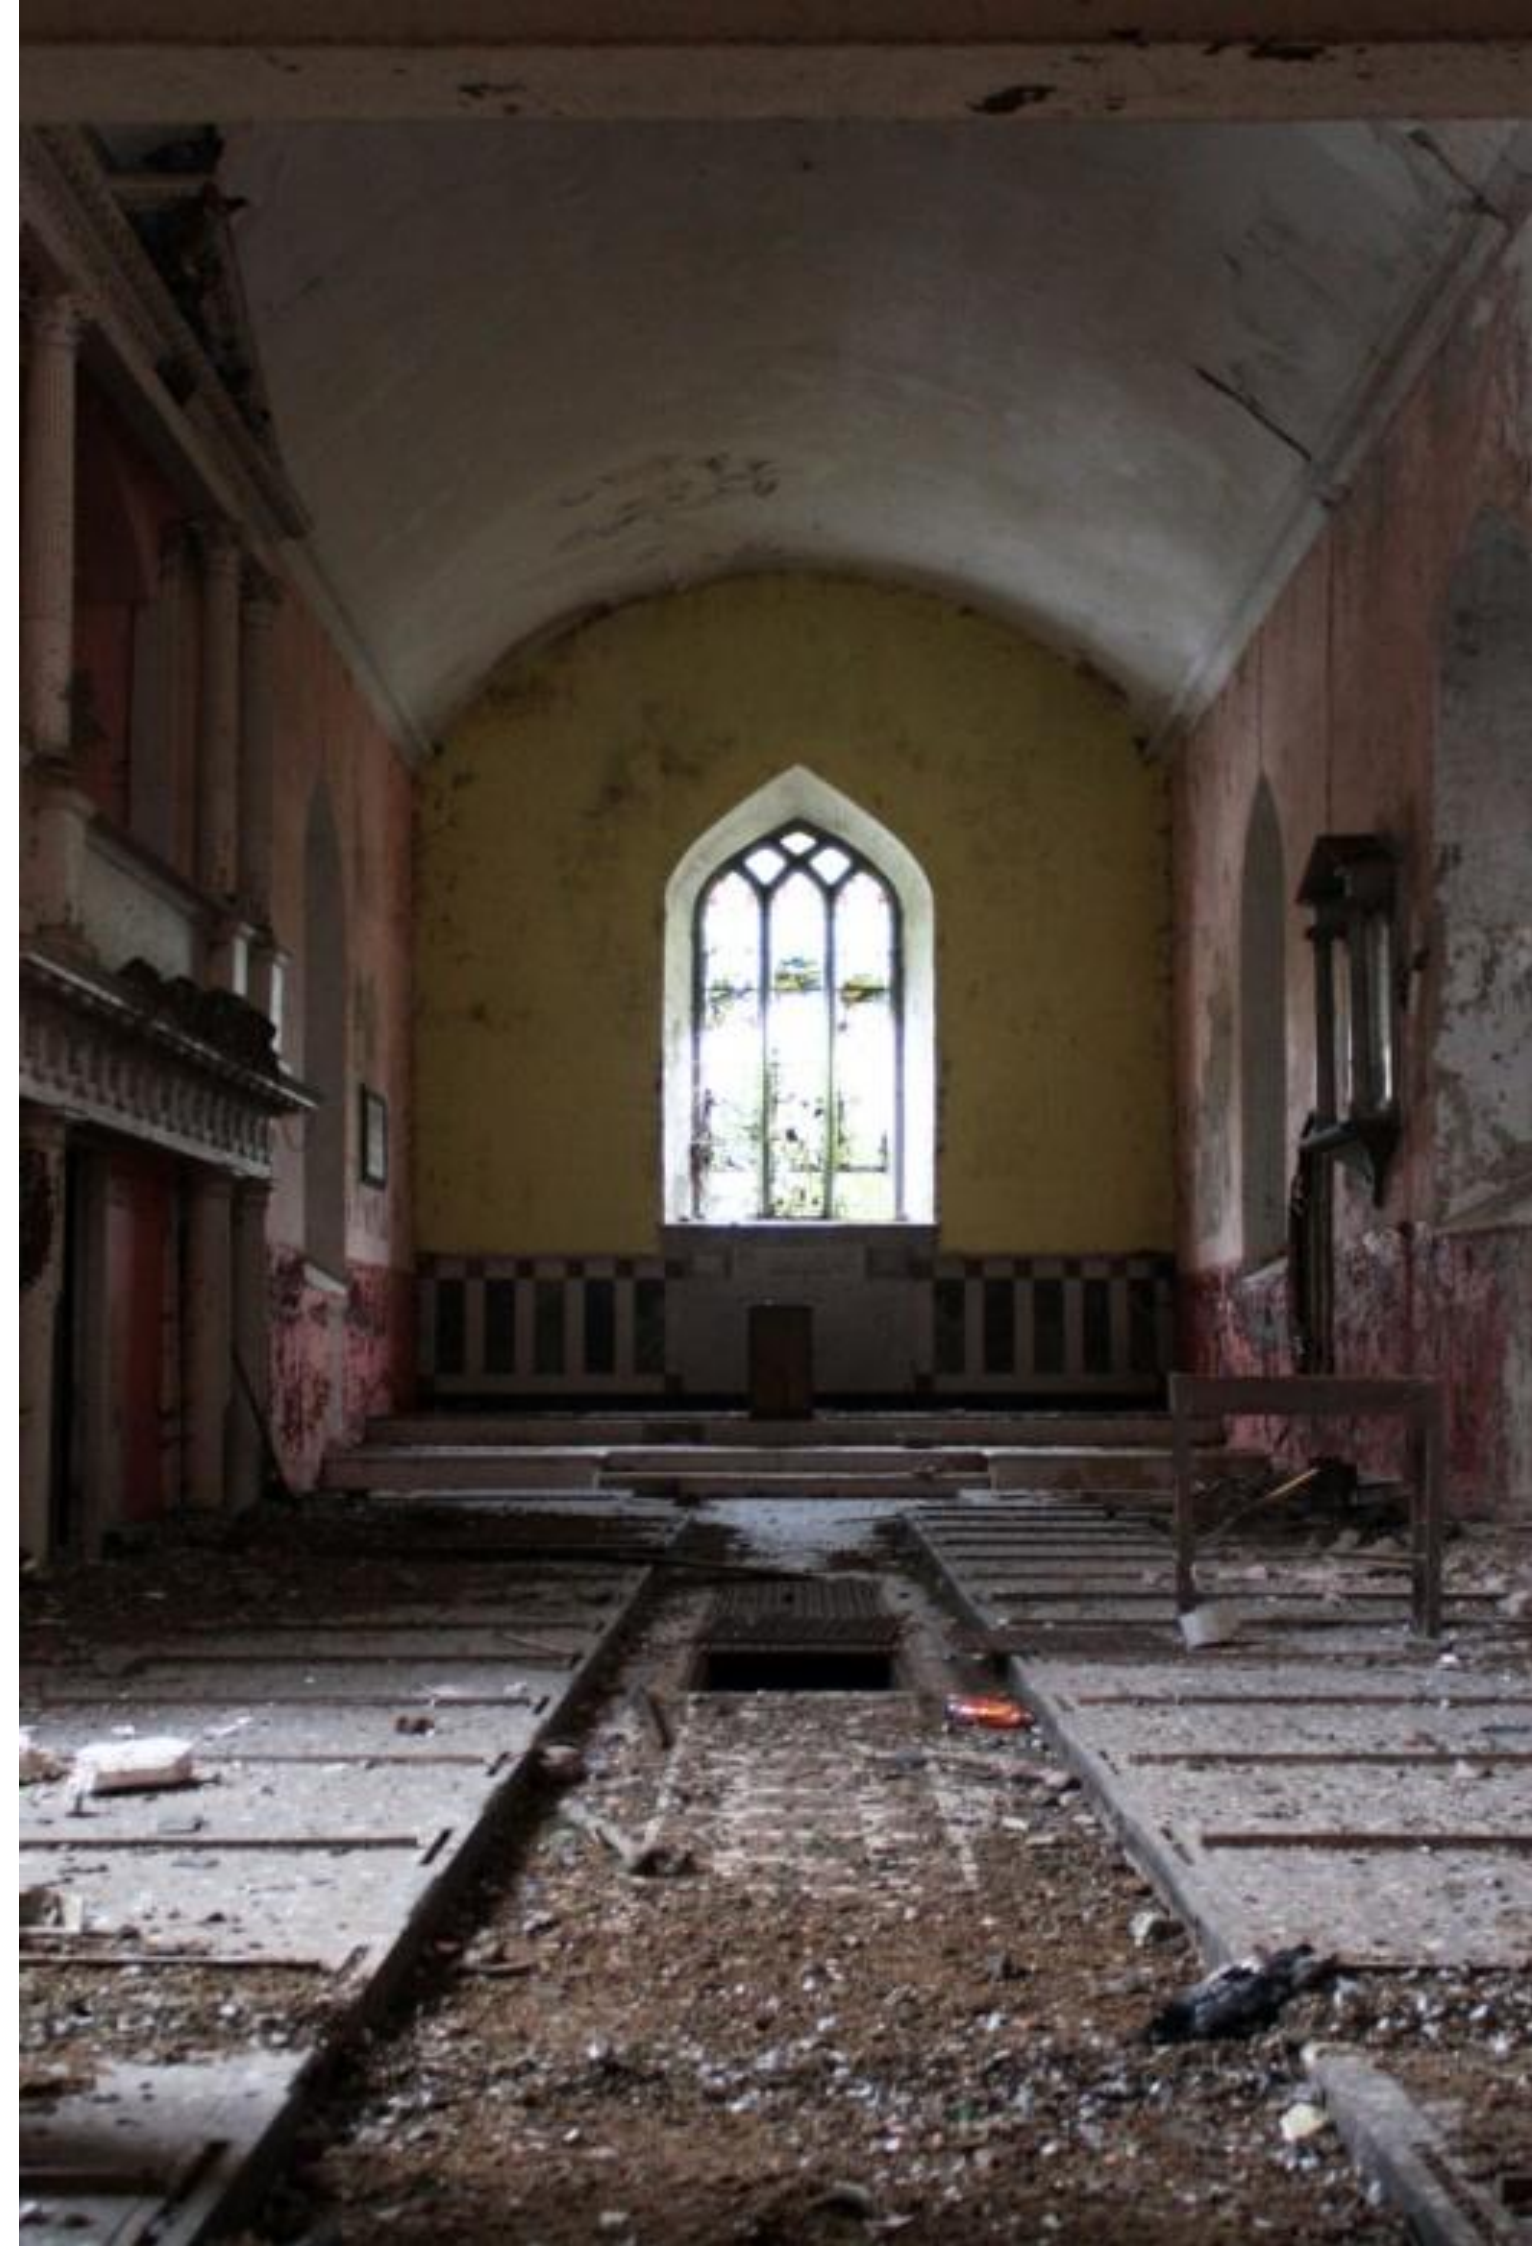
Christchurch is an 18th century church in the centre of Rathcormac with early 19th century alterations. Of interest is its private gallery space to the side with double classical colonnade into the church opening. The building has been unused for some time and has fallen derelict with its windows blocked up and internal features becoming lost. Given its location in the village centre, a new community or educational use is most appropriate to prevent further deterioration of its character.

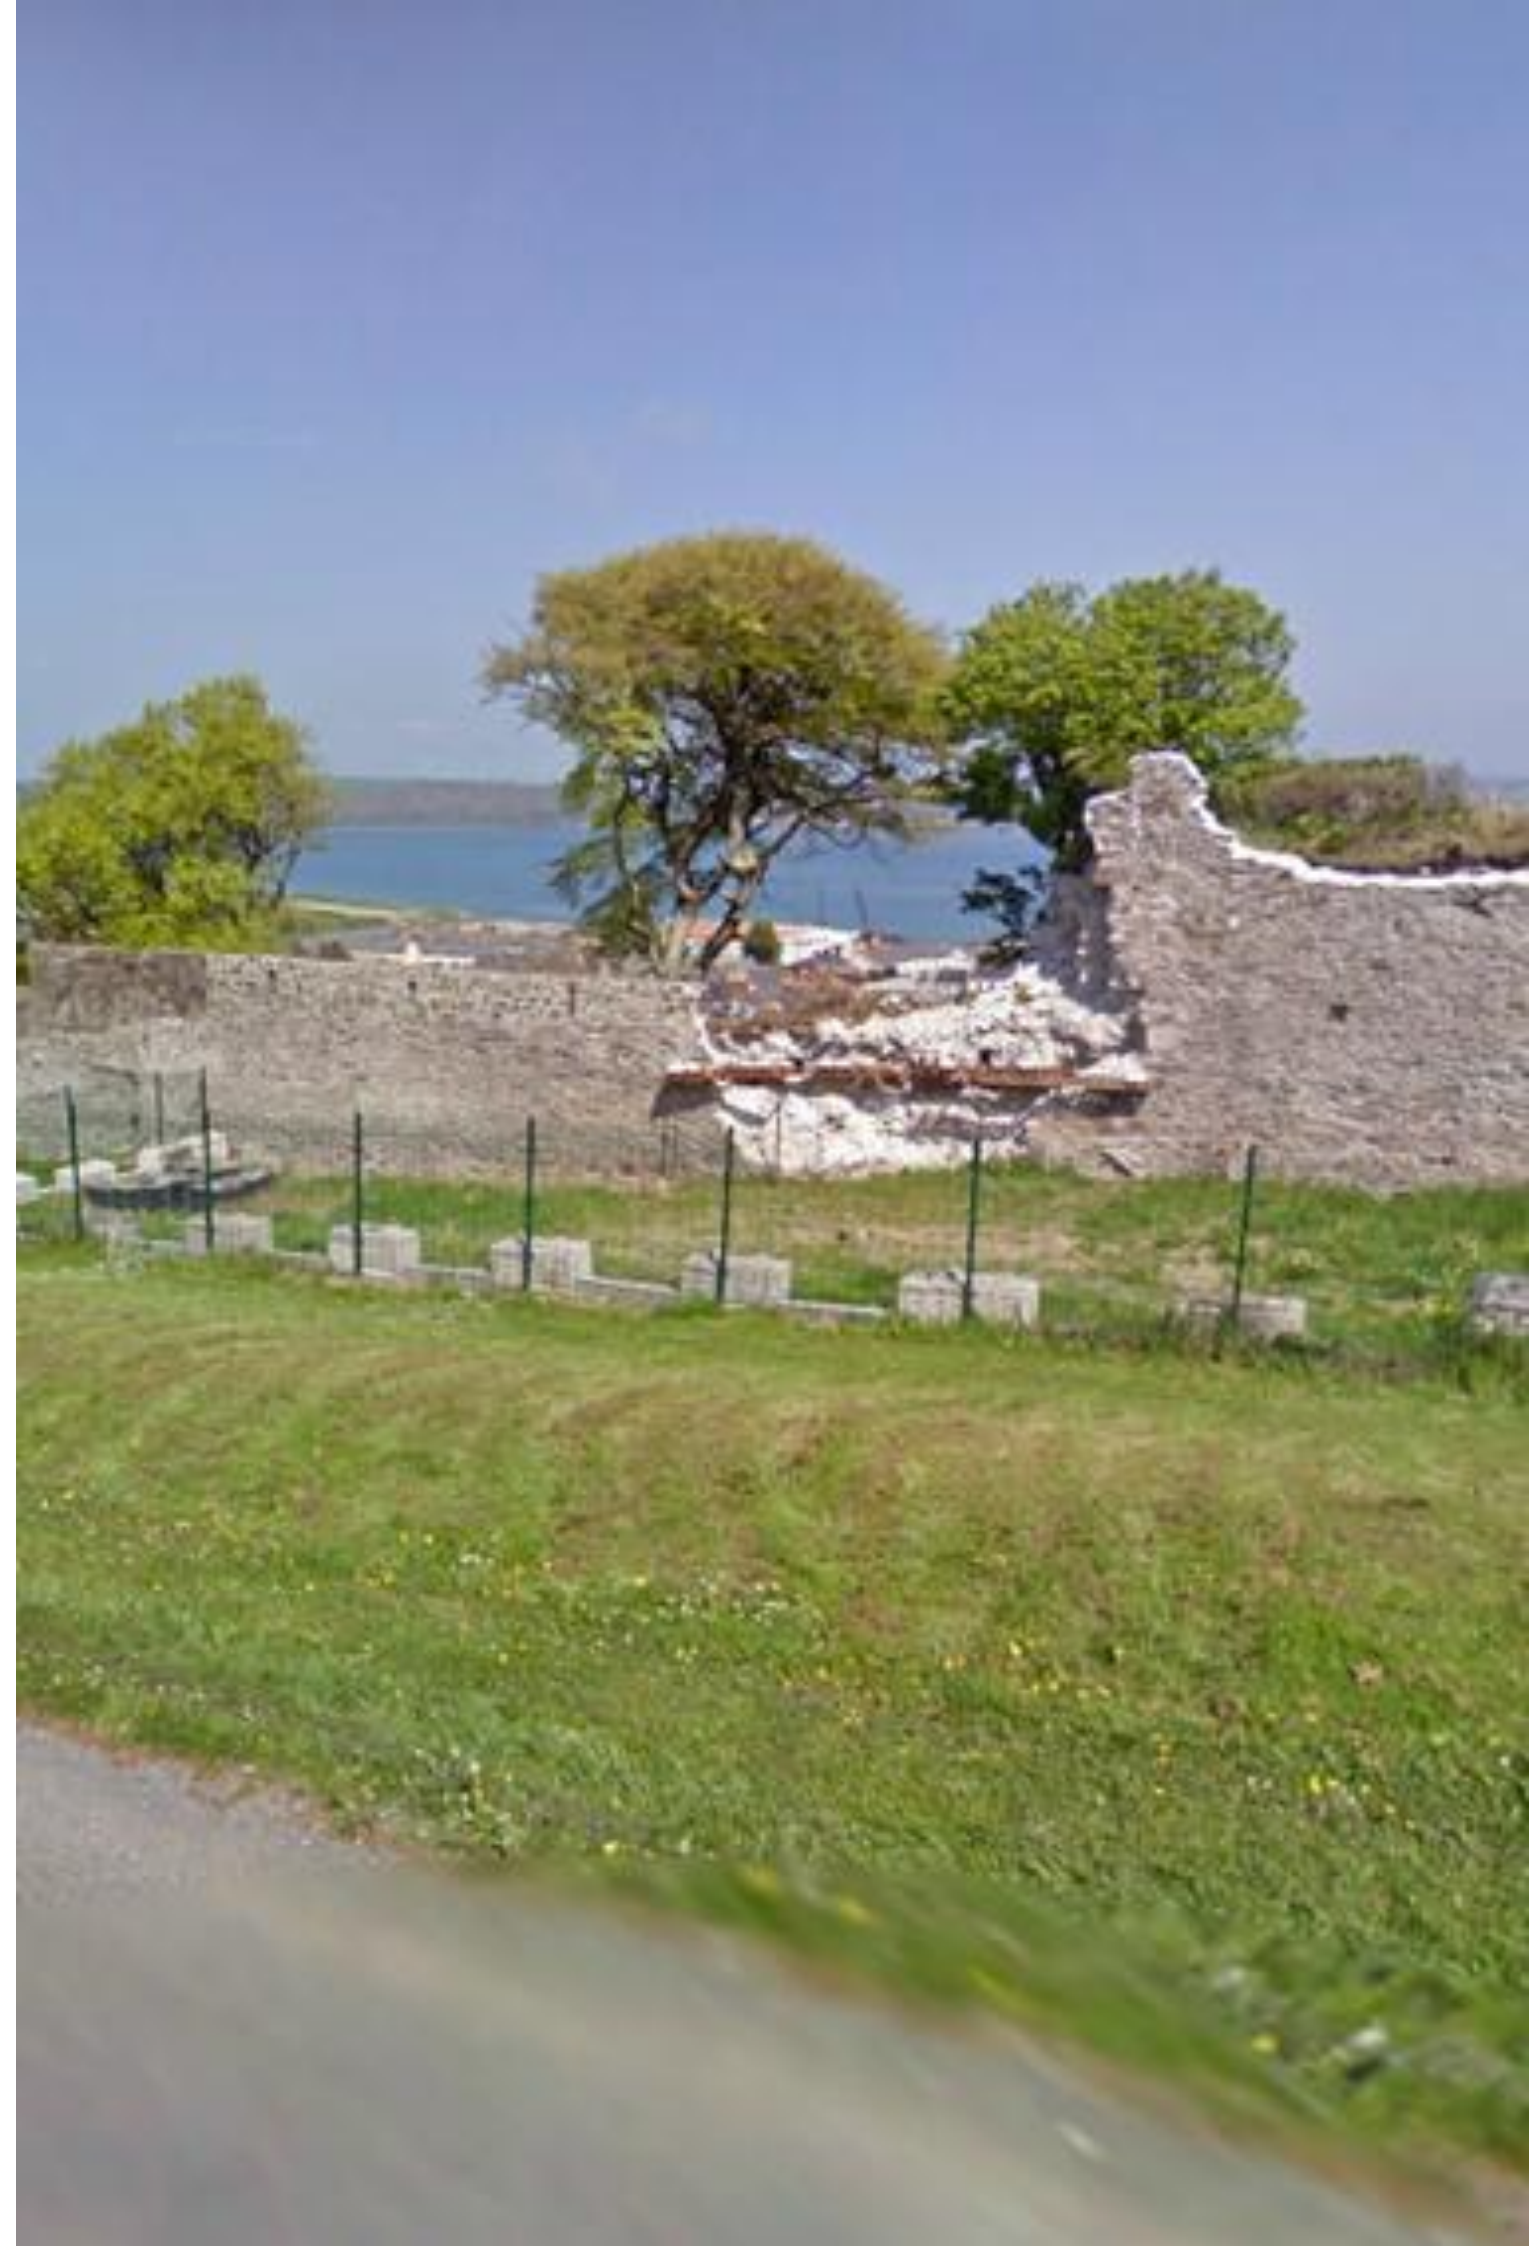
Youghal is one of Ireland's finest historic towns retaining significant portions of its medieval defensive walls. The walls are extensively damaged and suffering from major conservation problems with a section on the elevated western side of the town collapsing in 2009 leaving its core masonry exposed. The repair of damage to the wall should be considered a national priority. The walls are of significant historic importance and require conservation works to prevent further deterioration.

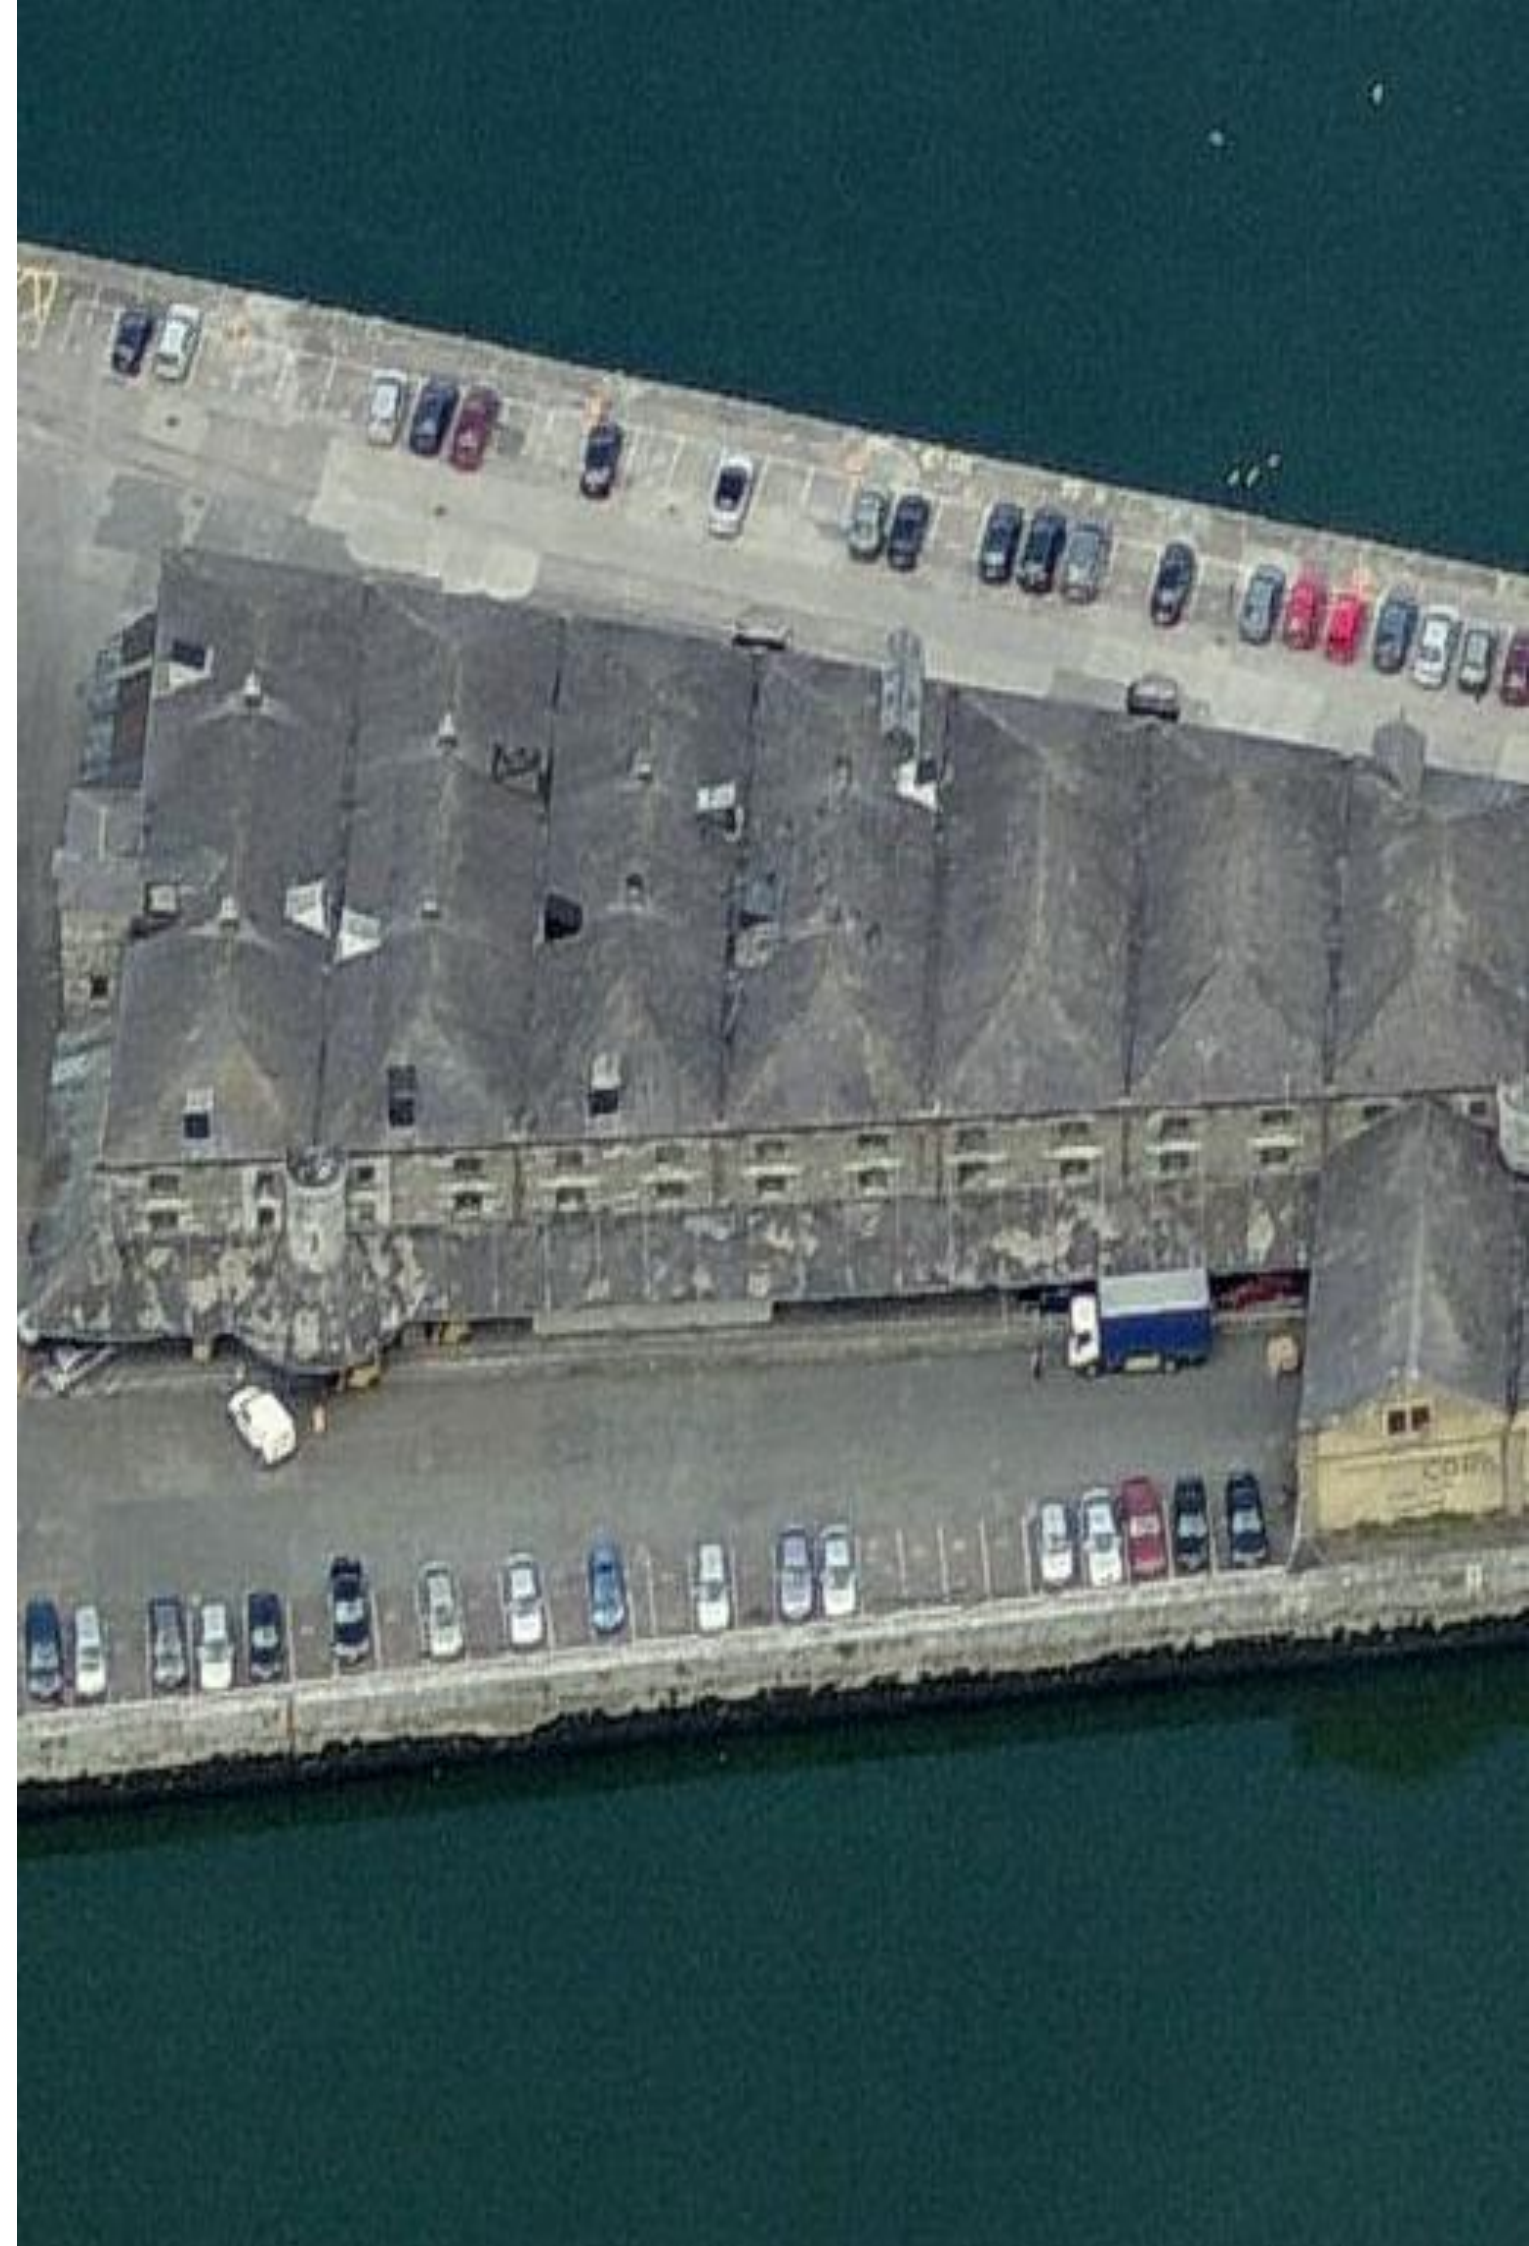
The early 19th century warehouse complex was constructed in conjunction with adjoining Custom House, but is now mainly vacant. There is a part of a slate canopy over the loading area which has been removed. A long term conservation plan and new use is urgently required for this prominent city centre location to prevent further deterioration.

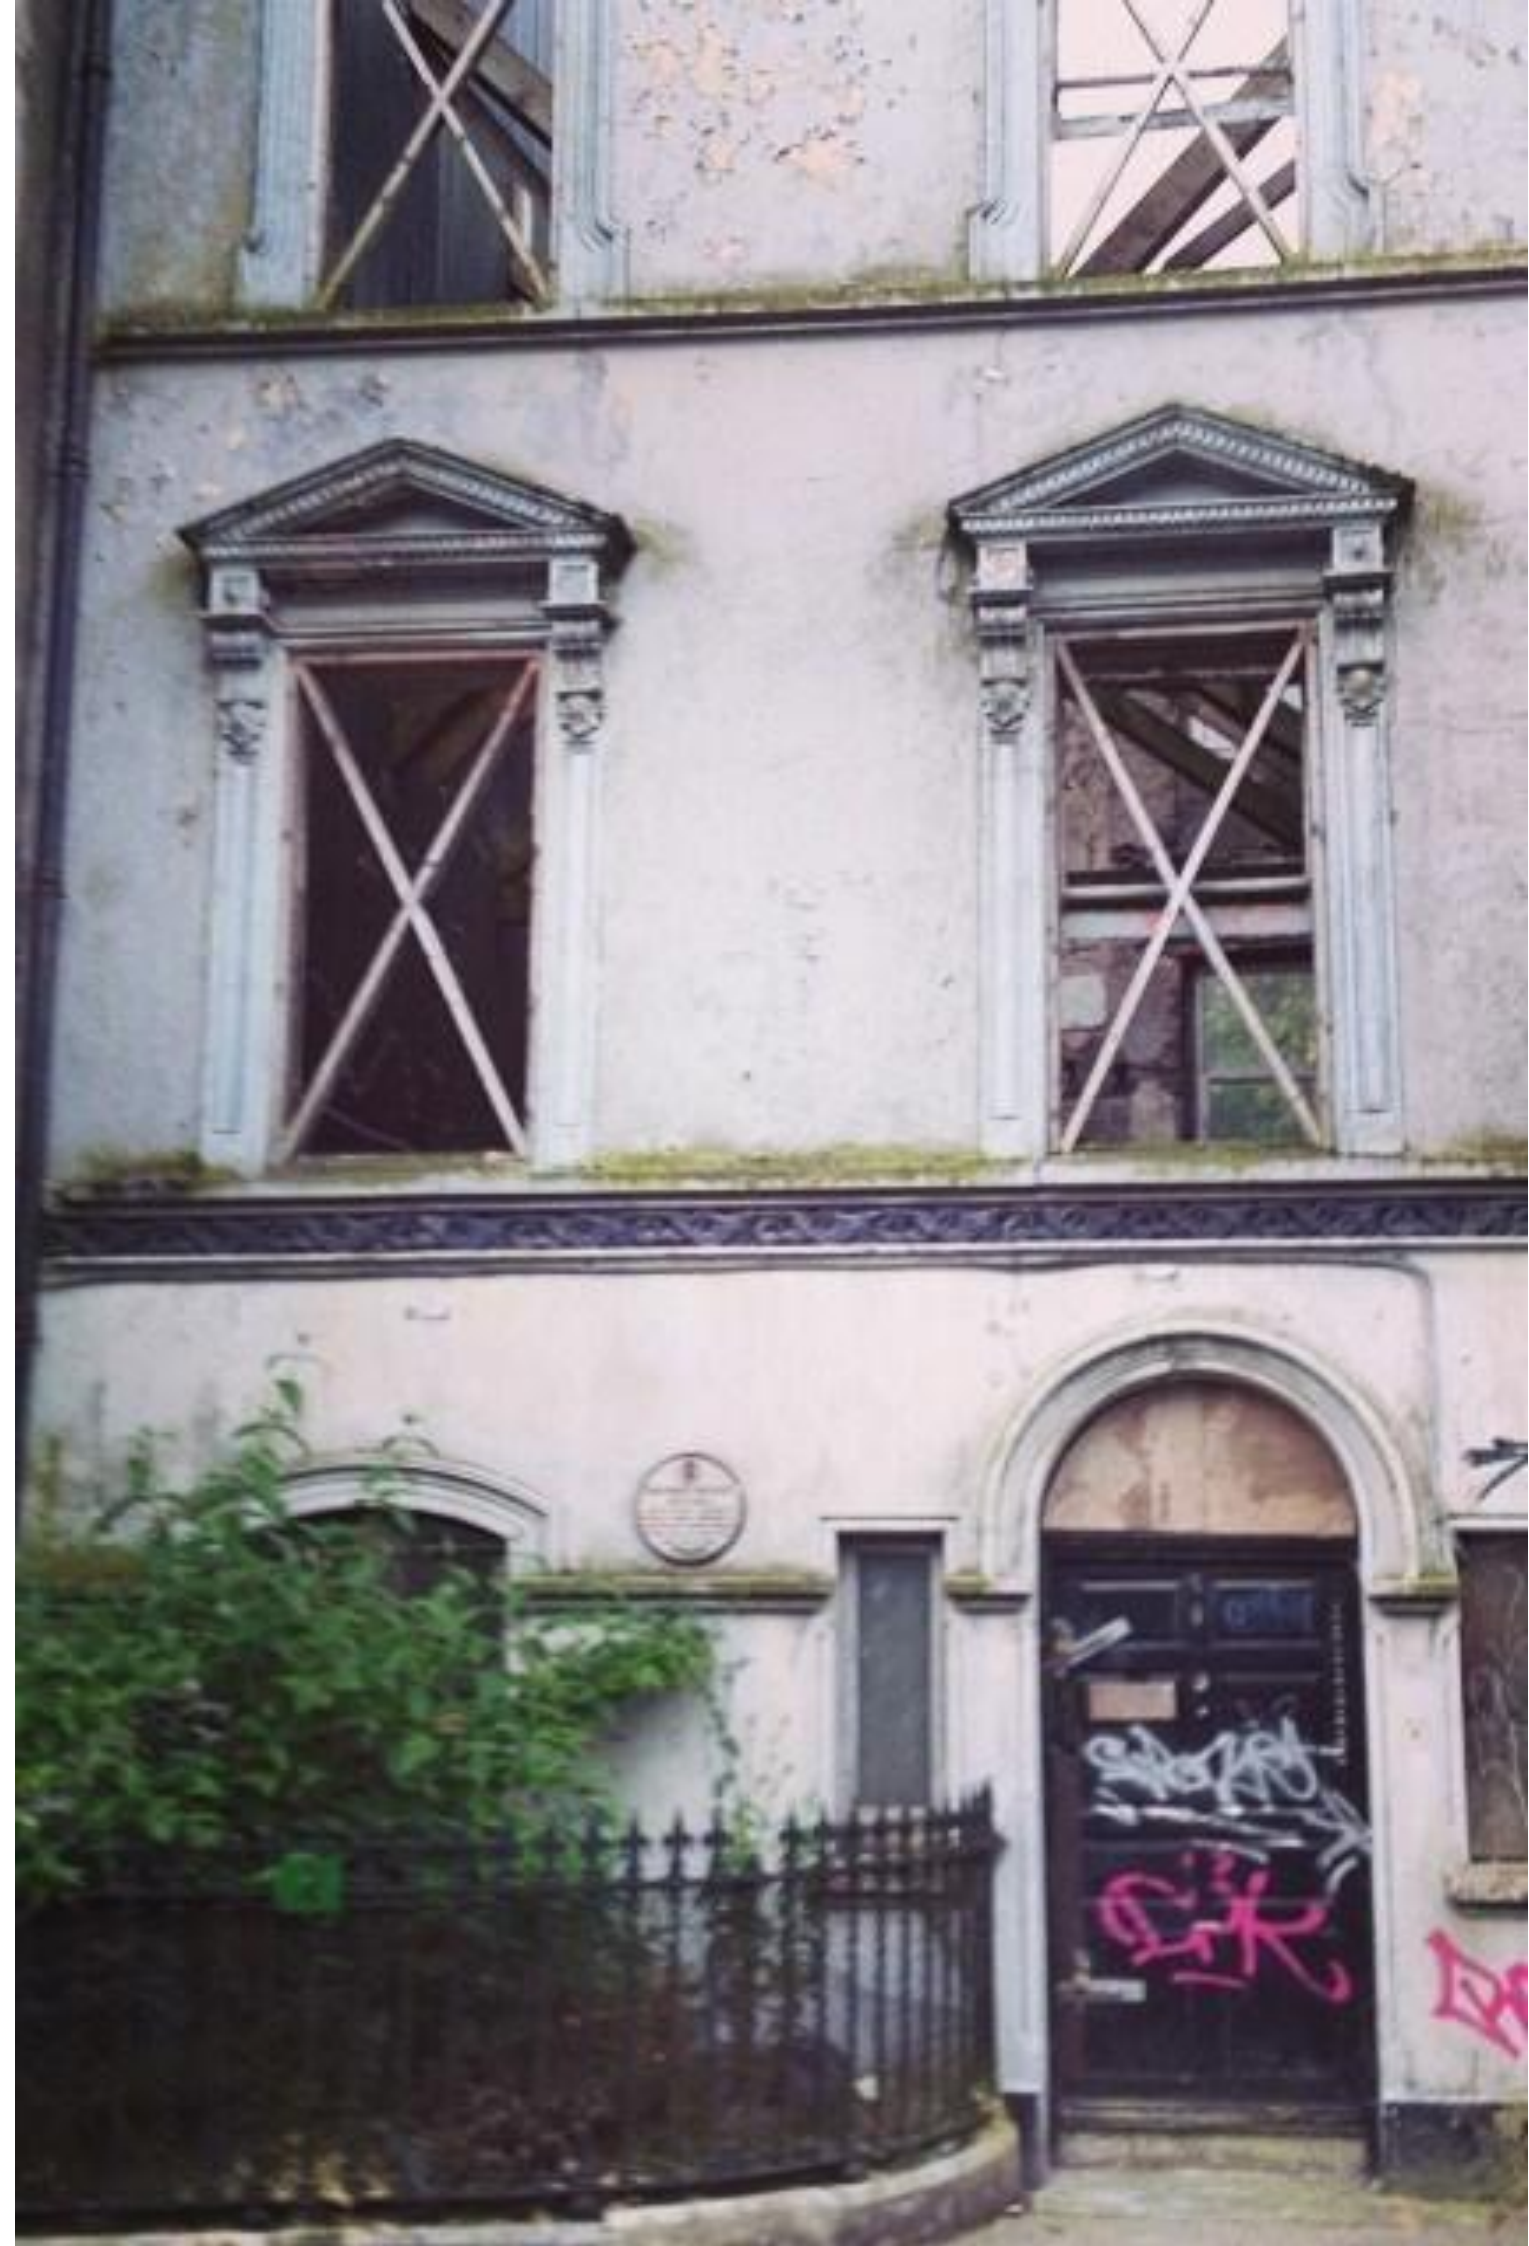
This terraced house is prominently sited opposite the North Mall in the heart of the city. The house was once occupied by the internationally important mathematician George Boole during his years in Cork. The house has been allowed to deteriorate rapidly in the last two to three years. The structure is now a roofless shell. The structure is of significant historic importance and require conservation works to prevent further deterioration.

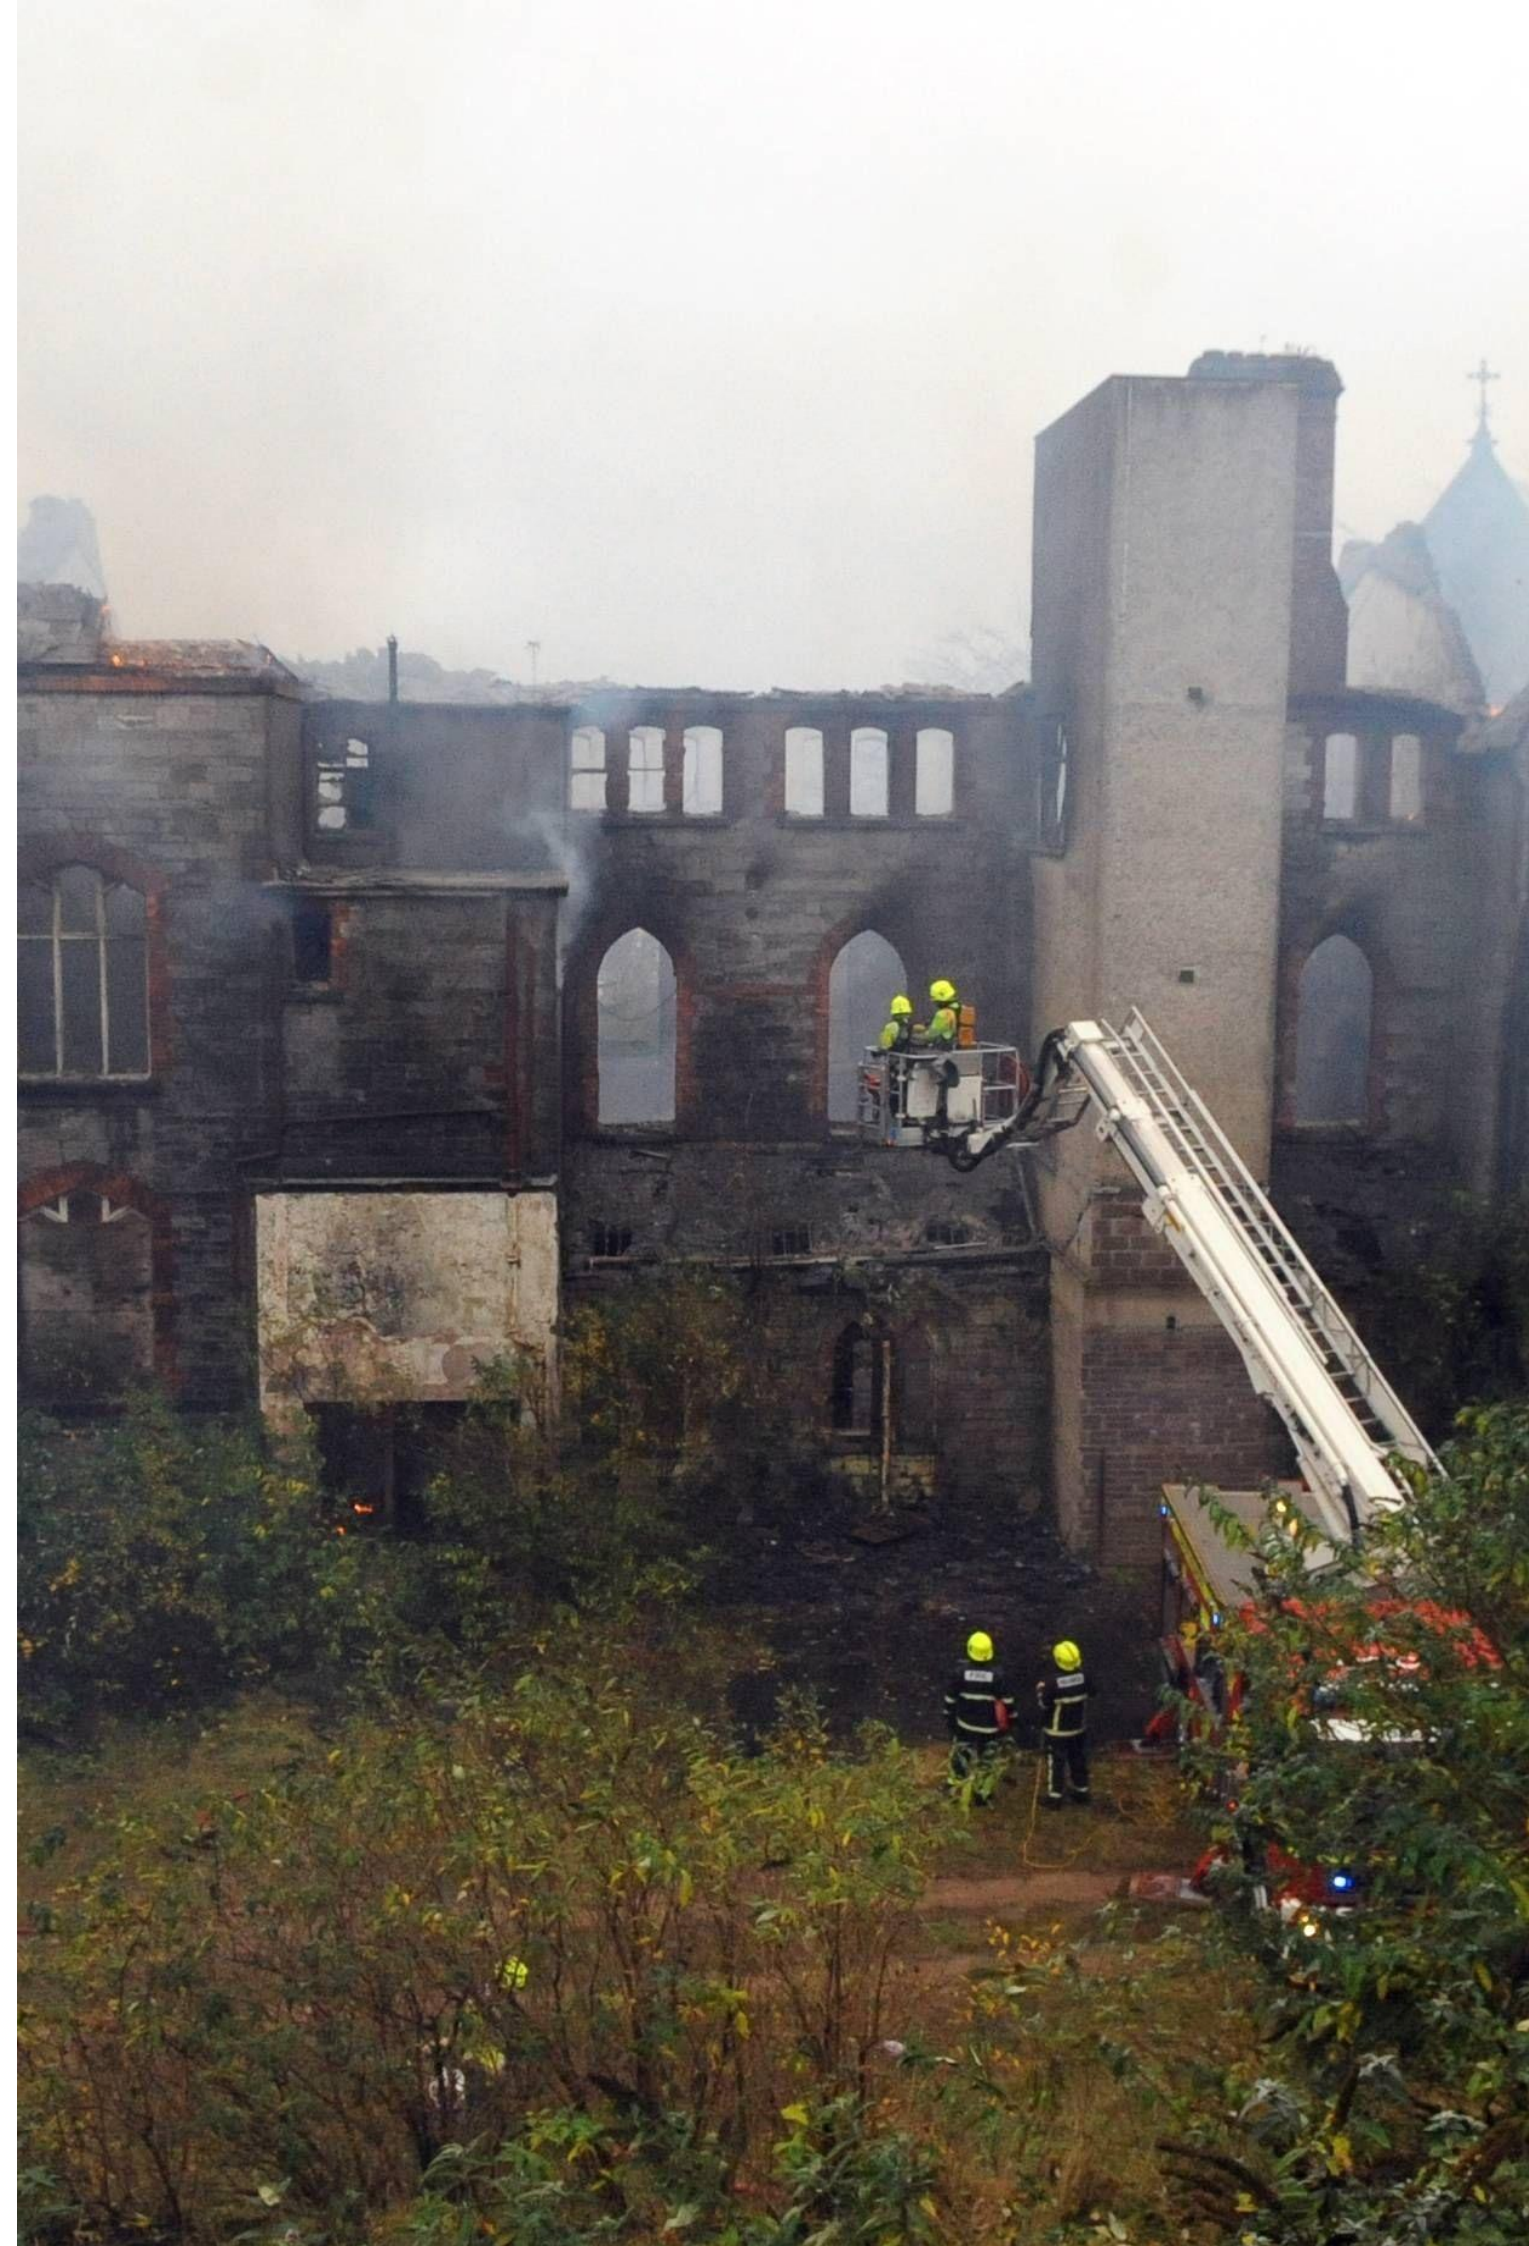
The impressive Italian gothic redbrick institutional complex designed by George Ashlin, circa 1890. Occupies prominent elevated site in Sunday's Well with views over wide area of Cork City. The building has suffered serious fire damage with destruction of chapel to the rear. Major intervention now required to secure the structure. The structure is of significant historic importance and requires conservation works and a new use identified to prevent further deterioration.

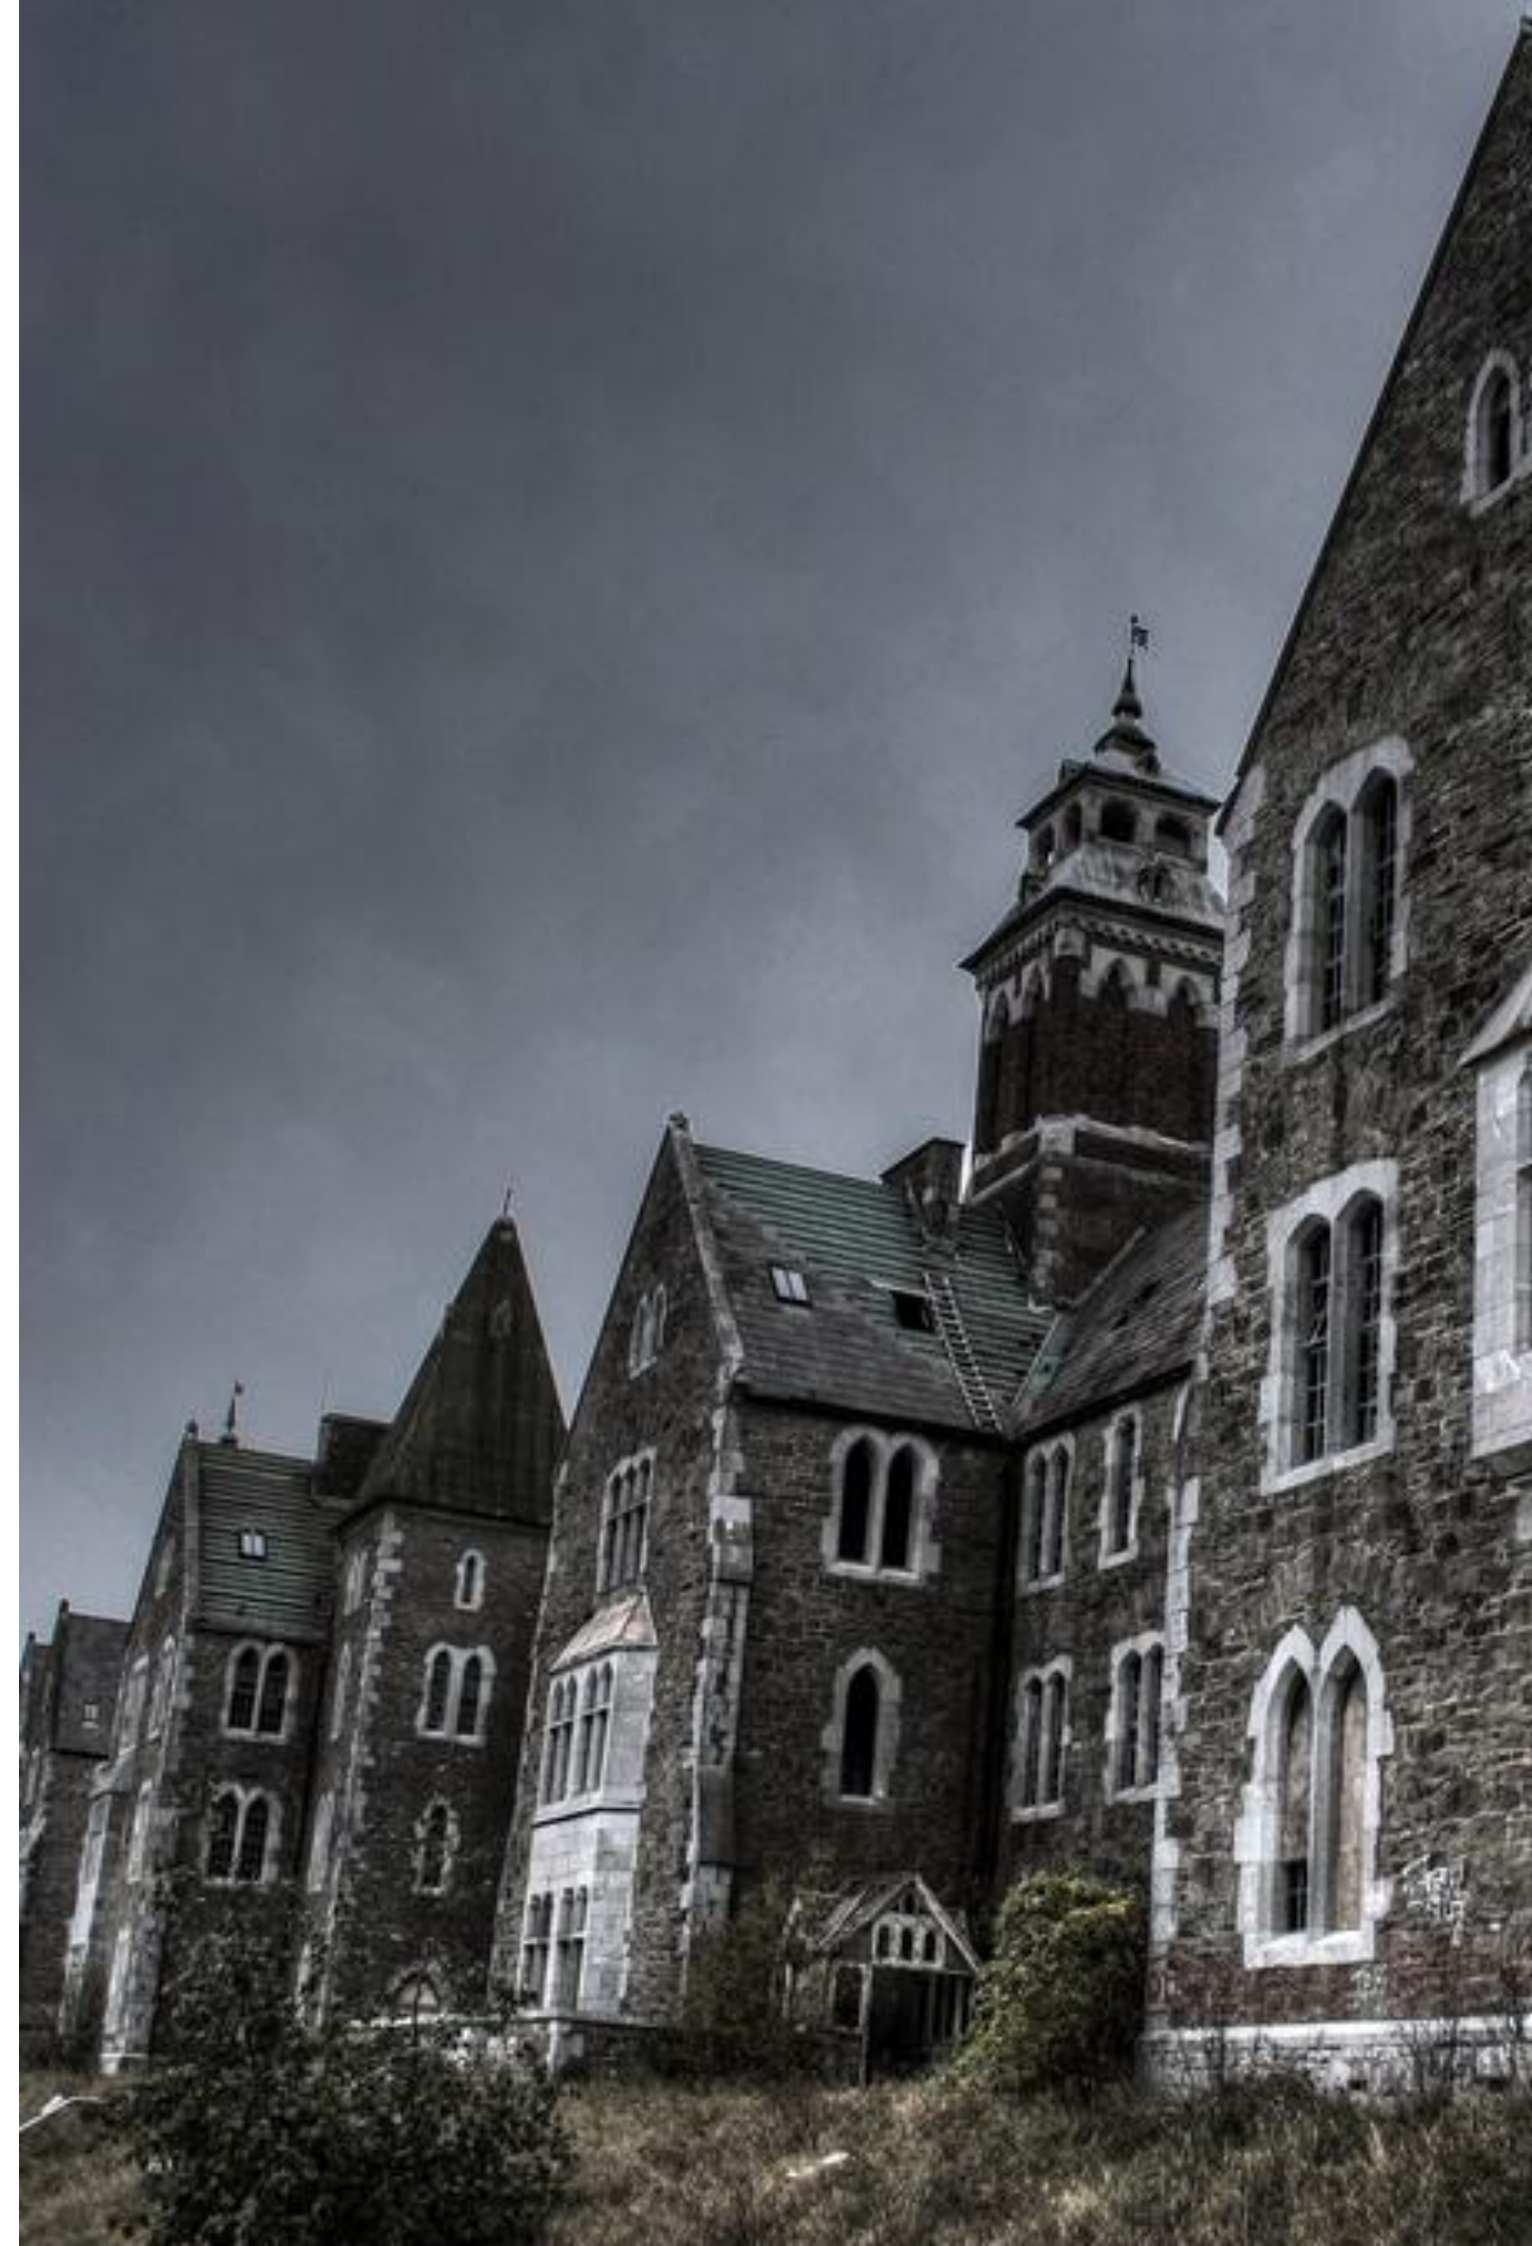
Designed by William Atkins, the random coursed stone, multi gabled elevation creates an impressive architectural massing. Formerly the Eglington Asylum, it is one of the largest 19th century institutional buildings in the country. It is prominently sited on ridge overlooking the Lee Valley to the west of city. Following vacation of hospital use, permission was granted for a conversion of the existing building to a new residential development. Only half of the existing building has been converted to apartments with the remainder left abandoned. Significant fire damage has occurred to the unfinished section in 2010. This building urgently requires new uses to be identified to prevent further deterioration of its character.
